Effectiveness of Post-fire Burned Area Emergency Response (BAER) Road Treatments: Results from Three Wildfires

Randy B. Foltz and Peter R. Robichaud

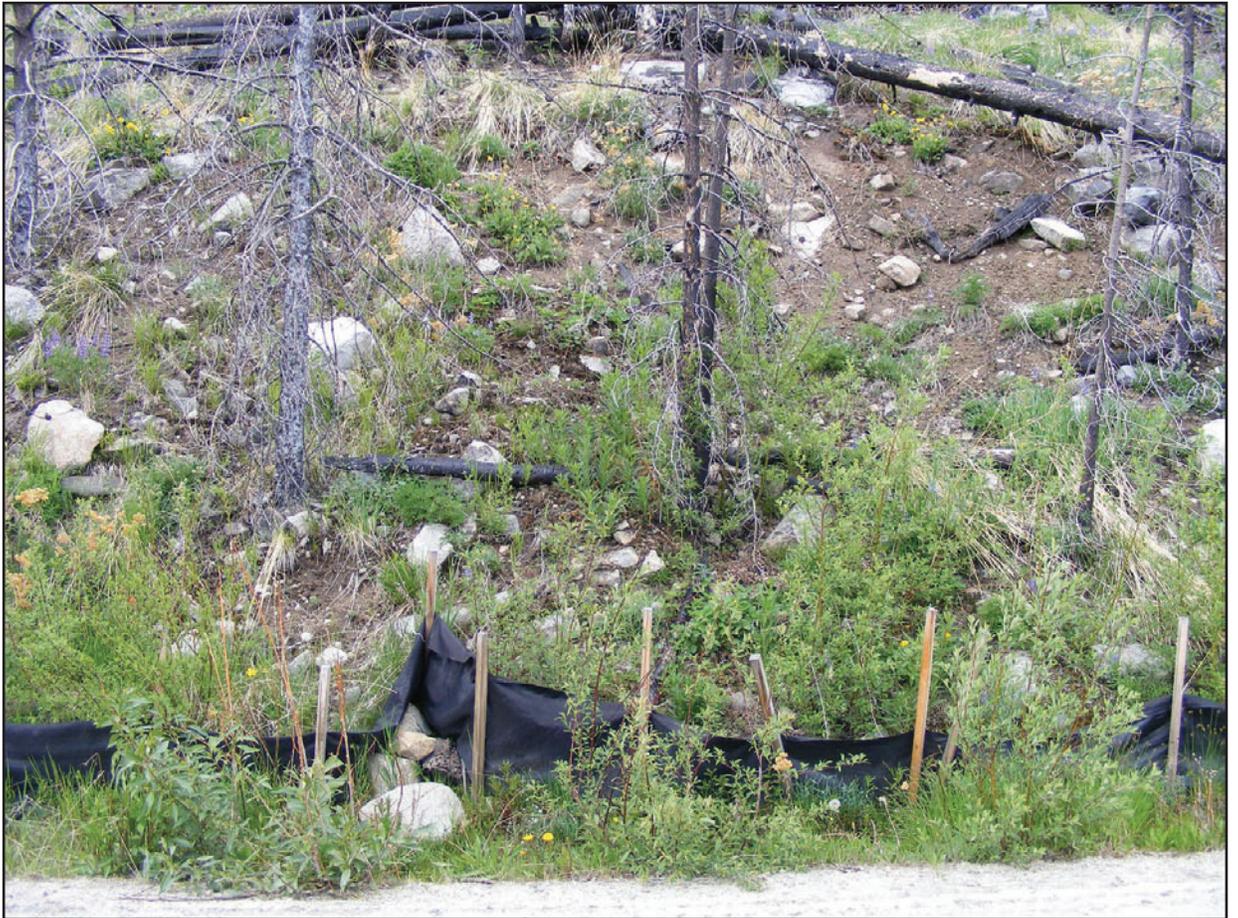
Figure 5—FS road 3700, Tripod Complex Fires, cutslope with no treatment (control) test section after 3 years. Note the predominance of forbs.

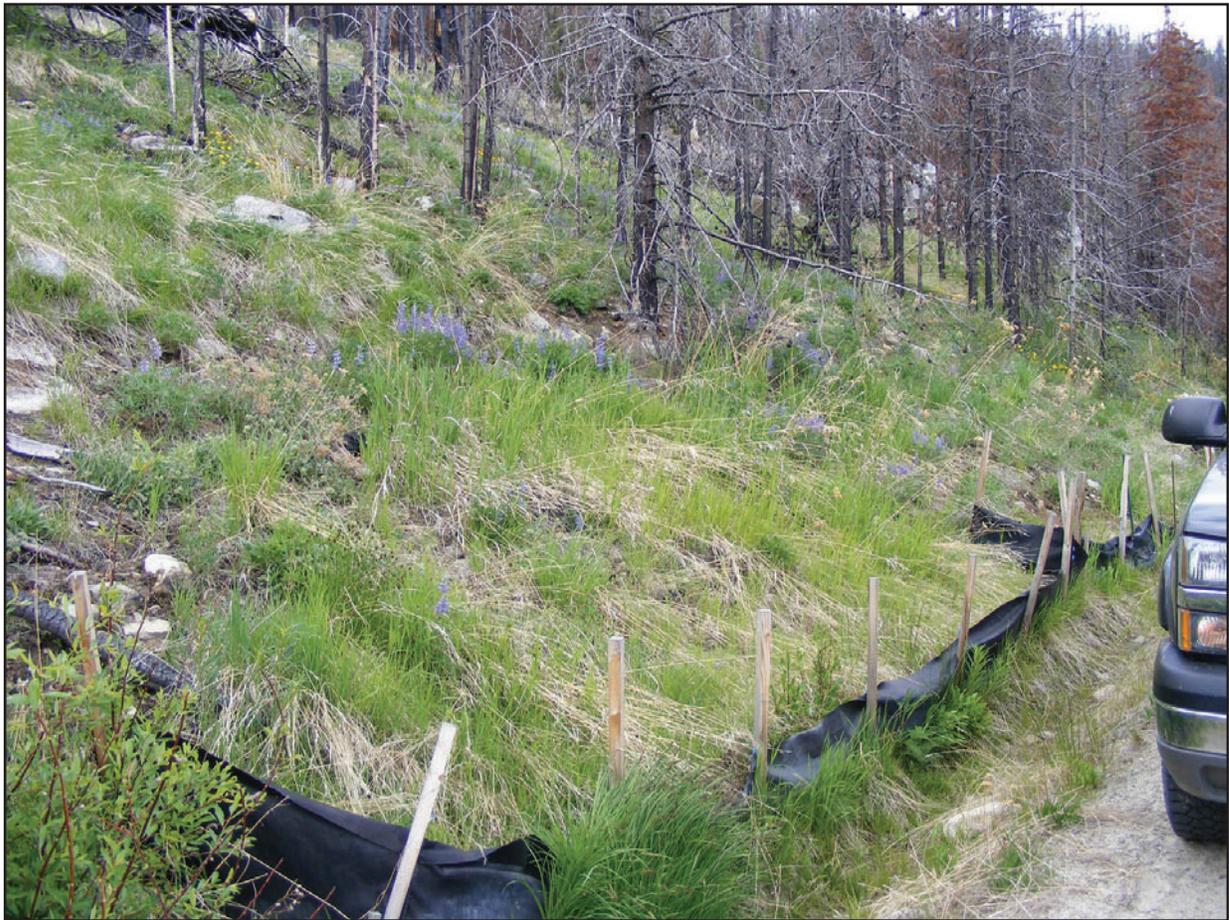
Figure 6—FS road 3700, Tripod Complex Fires, cutslope with roadside hydromulch test section after 3 years. Note the predominance of grasses.

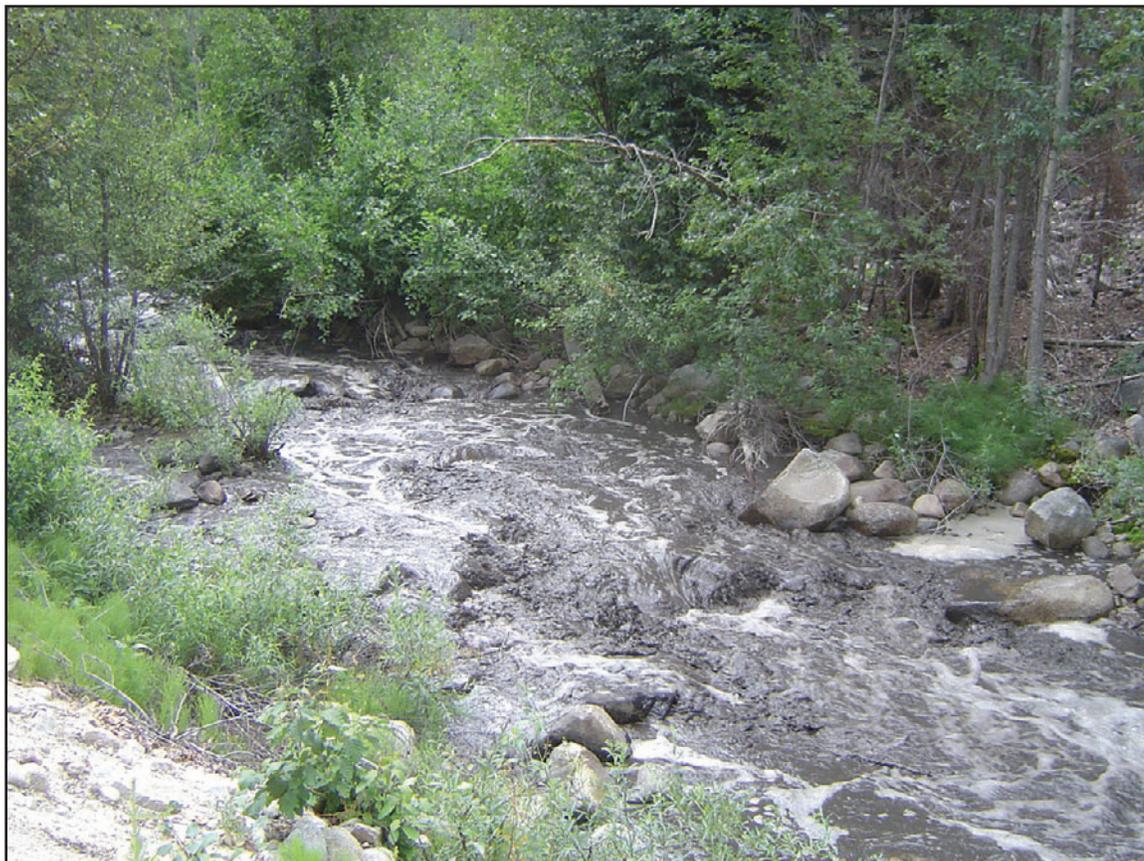
Storms of July 18 and 19, 2007—On July 19, 2007 a thunderstorm caused high flows on Boulder Creek (fig. 9) to erode a section of FS road 3700 located 6 miles from our FS road 3700 locations and 2 miles from our FS road 5009200 locations. None of our study locations were impacted by this series of storms. The nearest rain gauge (RG16) was 1.4 miles (2.3 km) southwest of the eroded section and in the drainage of Boulder Creek. On the previous day, July 18, precipitation at RG16 was 0.76 inches (1.9 cm) with 1-hour, 30-minute, and 15-minute intensities of 0.29, 0.56 and 0.76 inches h⁻¹ (0.74, 1.4, and 1.9 cm h⁻¹), respectively. Both the depth and the individual intensities

Figure 9—Boulder Creek below road washout on July 19, 2007, Tripod Complex Fires.

were the maximum for the year at the rain gauge. On the day of the high flow, July 19, RG16 measured 0.27 inches (0.69 cm) with 1-hour, 30-minute, and 15-minute intensities of 0.11, 0.22, and 0.28 inches h^{-1} (0.28, 0.56, and 0.71 $cm\ h^{-1}$), respectively. High soil water content from the previous day's precipitation combined with the precipitation of July 19 resulted in the high flows at Boulder Creek.

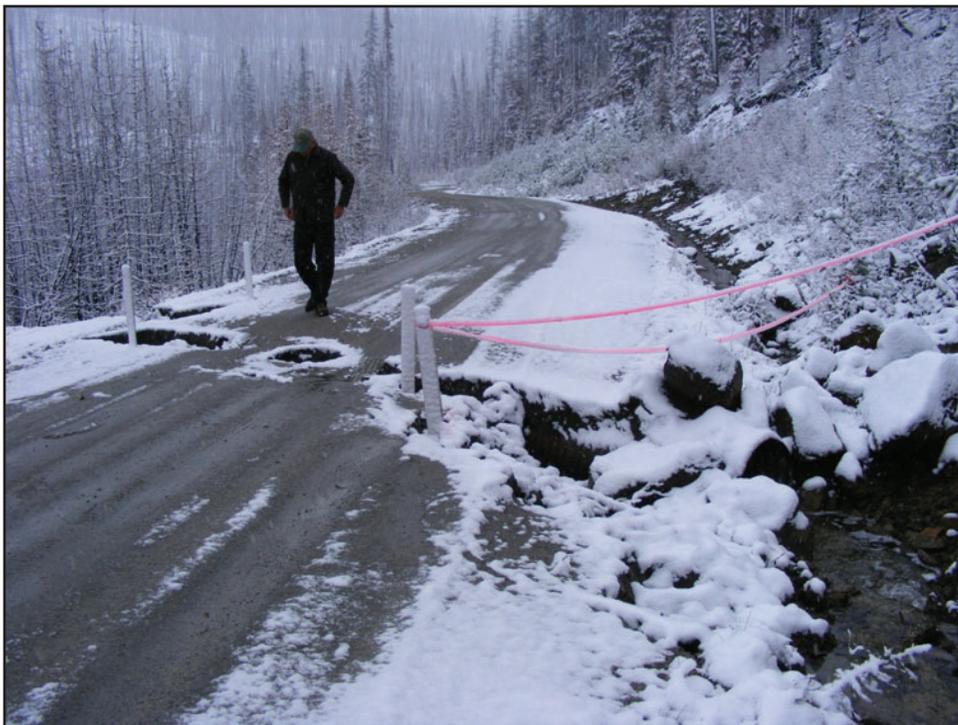
Winter of 2007-2008—The winter of 2007-2008 had 180 percent of normal snow packs in mid-April. In mid-May, rapidly warming temperatures caused the Methow River at Winthrop, Washington to peak at 300 percent of the mean daily flows. All of the study sites were able to accommodate the spring snowmelt period. Several sections on FS roads 3700 and 3900 failed and required repair. On FS road 3700, 0.6 miles uphill from our last location, a culvert failed resulting in a washout around the culvert (fig. 10). Our observation was that the angle between the culvert and the ditch was too sharp to allow the water to make the turn into the culvert, which caused water to erode around the culvert.

Figure 10—Culvert failure on FS road 3700 following winter 2007-2008, Tripod Complex Fires.

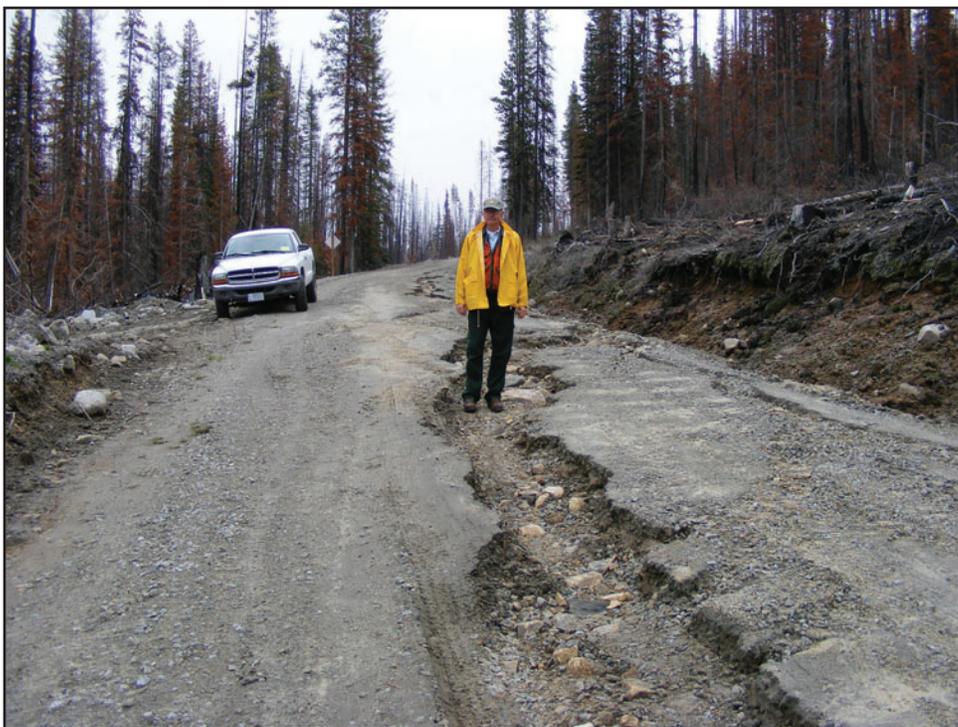
On FS road 3900 we observed extensive rilling on the running surface for 0.5 miles (0.8 km) on a steep section (~10 percent grade) descending from Freezeout Pass located between two of our measurement locations (fig. 11). Flow came off the cutslope, exceeded the capacity of the ditch, then flowed on the running surface causing multiple rills varying in width from 4 to 12 inches (10 to 30 cm) wide with depths up to 4 inches (10 cm) deep. The source of the cutslope flow was a ditch relief culvert on a spur road off FS road 3700.

Figure 11—Road failure on FS road 3900 below Freezeout Pass following winter 2007-2008, Tripod Complex Fires.

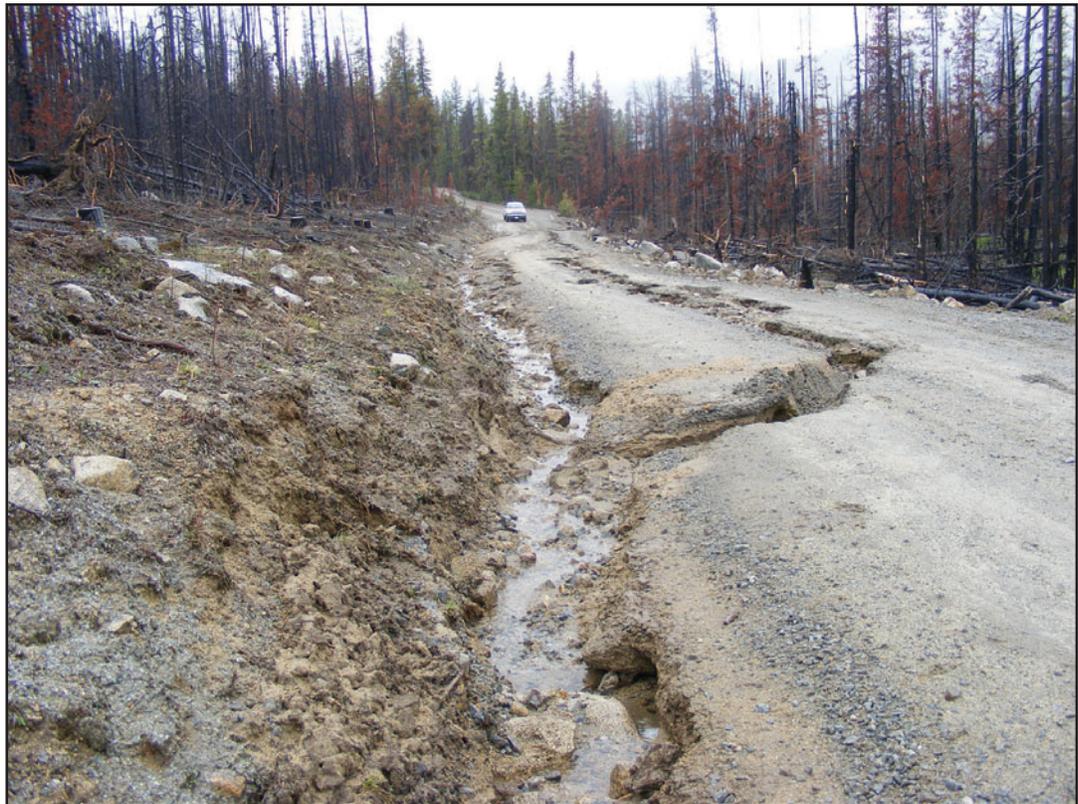
At higher elevations within the Tripod Complex Fire perimeter, we observed impassable, heavily rilled road running surfaces (fig. 12). We surmised that during the rapid snowmelt the fill slope side of the running surface was snow-free while the cutslope and ditch side retained a snowpack. Snow melt ran at the edge of the snowpack and caused erosion in some places and sediment deposition in others (fig. 13). We observed similar occurrences of this phenomenon in several locations.

Figure 12—Failures on FS road 3900 following winter 2007-2008, Tripod Complex Fires.

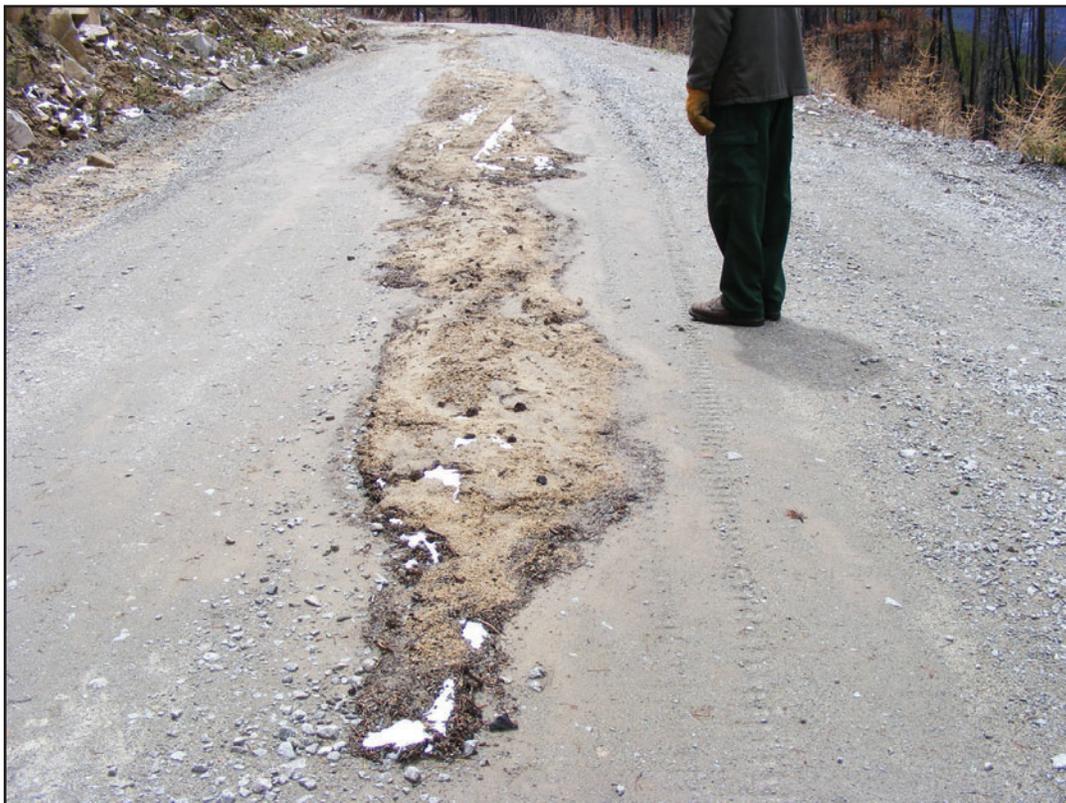
Figure 13—Sediment deposition along centerline of FS road 3700 following winter 2007-2008, Tripod Complex Fires. Location of sediment suggests that flow was at edge of snowpack on cutslope side of the road.

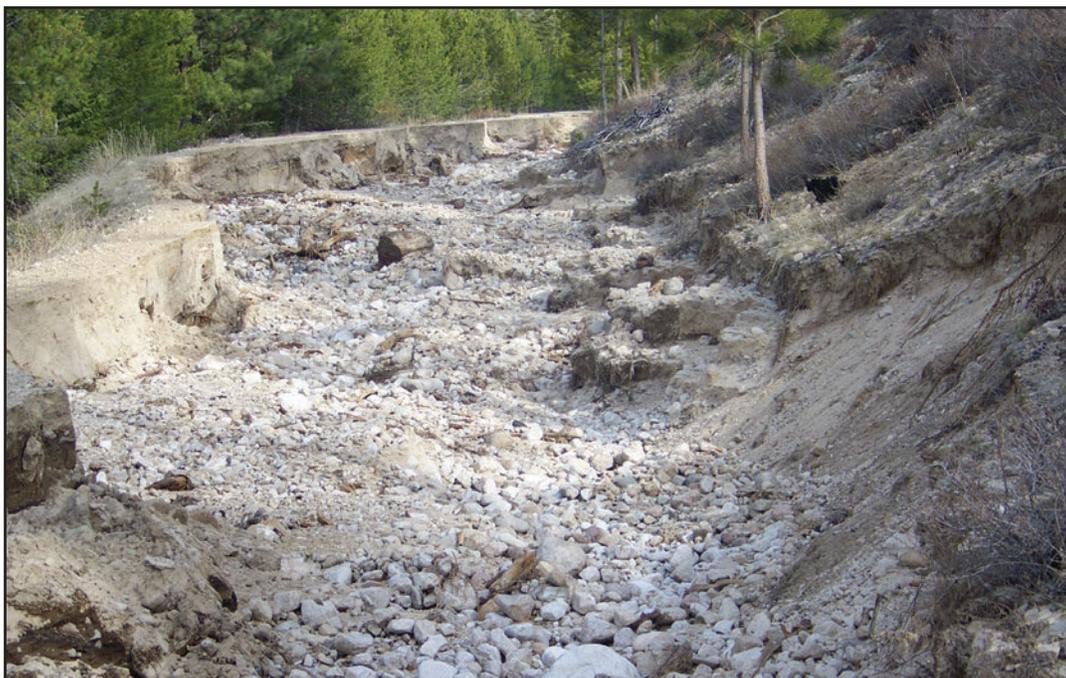
Winter 2008-2009—In the spring of 2009, FS road 3700800, Bromas Creek Road, was found to be essentially completely washed out due to snowmelt flowing on the running surface (fig. 14). Bromas Creek, a tributary to Boulder Creek, was between our FS road 5009200 and FS road 3700 locations. All of our measurement locations were able to accommodate the winter 2008-2009 snowmelt.

Figure 14—Washed out FS road 3700800 following winter 2007-2008, Tripod Complex Fires.

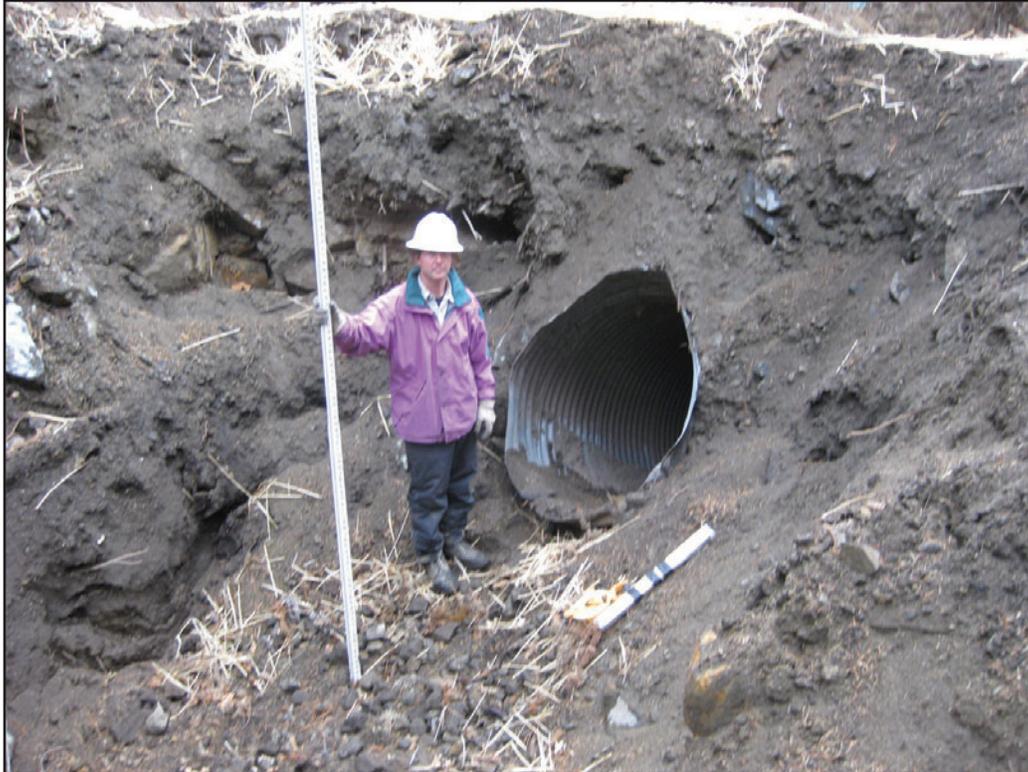
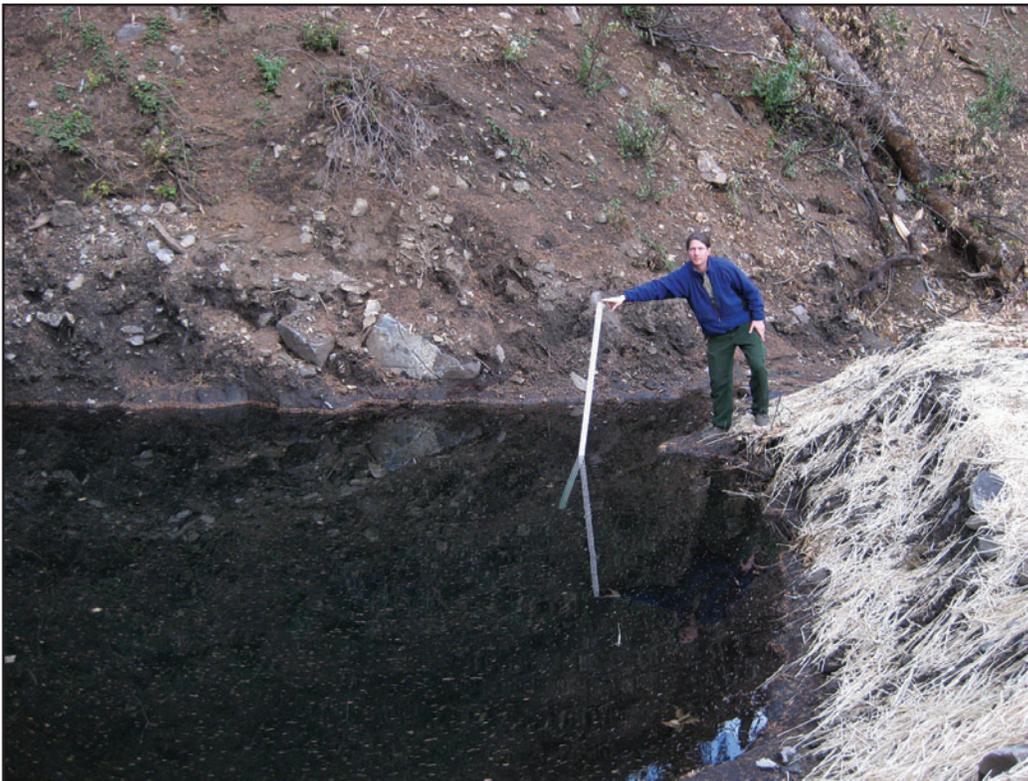
Figure 19—Catch basin before and after storms of early November 2008, Klamath Theater Complex Fires.

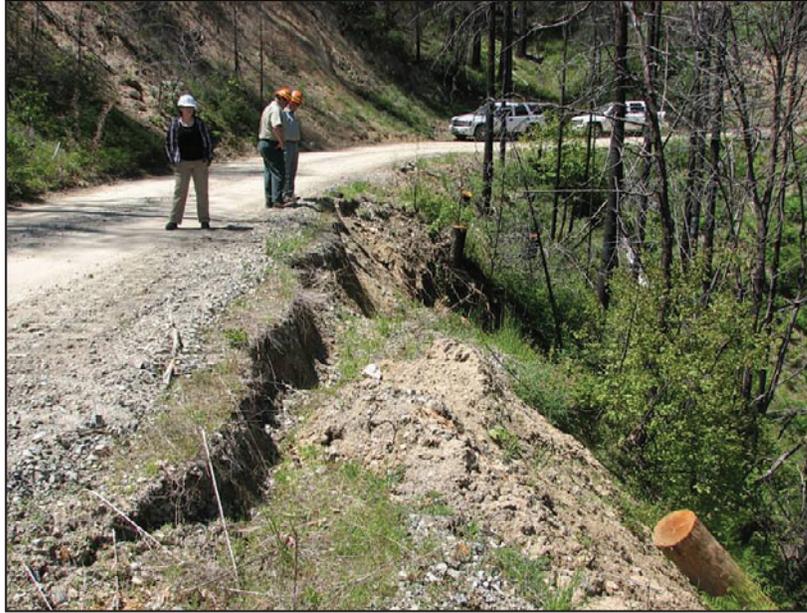
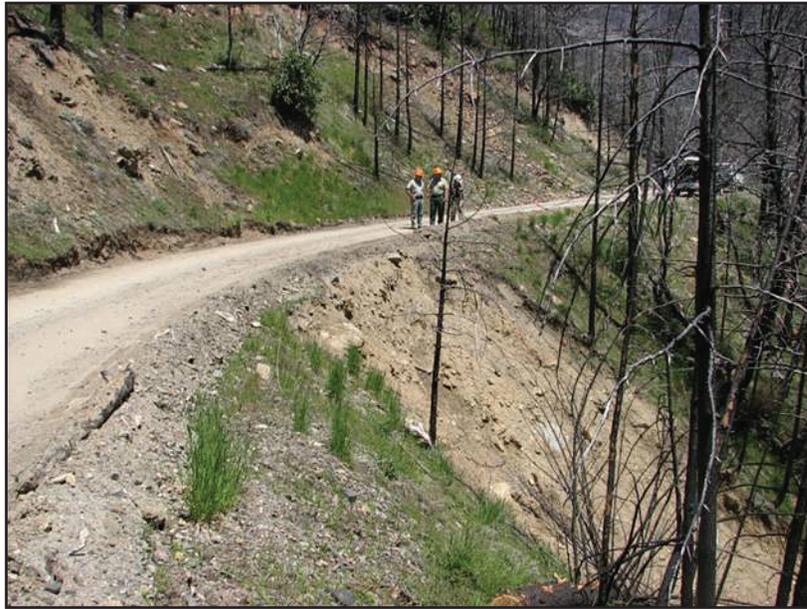
Events of March 2012—The period from 15 to 31 March had a total of 12.39 inches (315 mm) with 15, 27, and 29 March each exceeding a daily precipitation of 2 inches (50 mm). This series of storms caused cut and fill slope failures in the Panther (Oct) area on the 15N06 and 15N03 roads. Several of the fill slope failures resulted in blocking vehicle passage. In addition to the fill slope failures, cracks in the running surface parallel to the fill indicated potential future full slope problems (fig. 20).

Our observations suggest that spring snowmelt combined with storms in excess of 2 inches (25 mm) in a day were able to raise the water table upslope from the roads, allow water to flow out of the cutslopes, and increase water saturation in the fill slopes leading to fill failures. This type of mass failure rather than the expected upslope mass failure removing road fills was the predominant post-fire road failure mechanism.

Figure 20—Fill slope failures following March 2012 precipitation events, Klamath Theater Complex Fires.
