Effectiveness of Post-fire Burned Area Emergency Response (BAER) Road Treatments: Results from Three Wildfires

Randy B. Foltz and Peter R. Robichaud

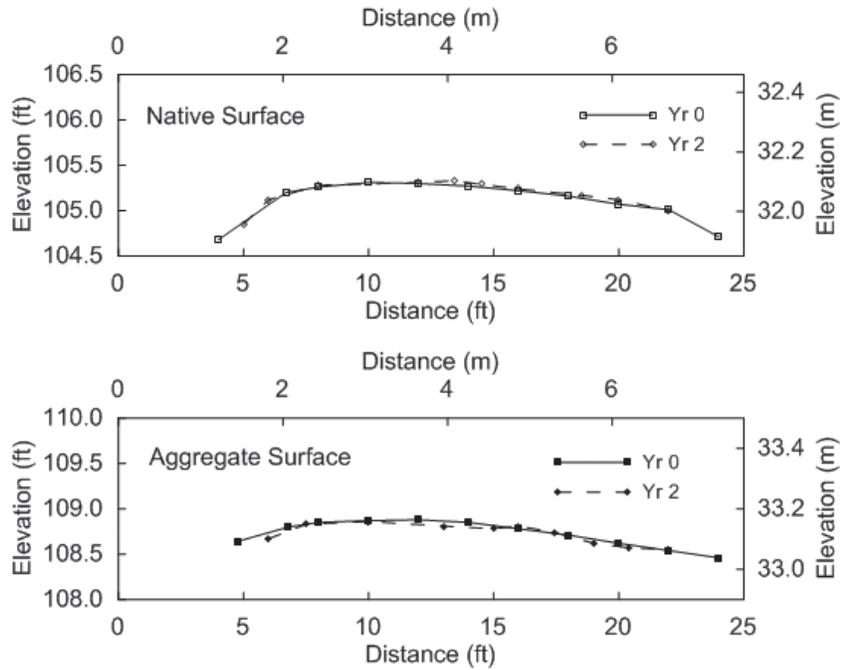
We observed no rutting of any of the aggregate test sections nor in any of the native surface sections. Most of the change in cross-section on the aggregate surface section was from movement of the individual aggregate particles rather than deepening of the wheel track (fig. 2). Although salvage logging on FS road 5009200 did occur, most of the logging truck traffic did not cross our test sections. The predominant traffic on FS road 5009200 was from hunters in pickup trucks in October of each year. Between 2400 and 4000 vehicles passed over our test sections.

Figure 2—Cross-section of native surface and aggregate surface road at Tripod Complex Fires before (Yr 0) and after (Yr 2) 4000 vehicle passes.

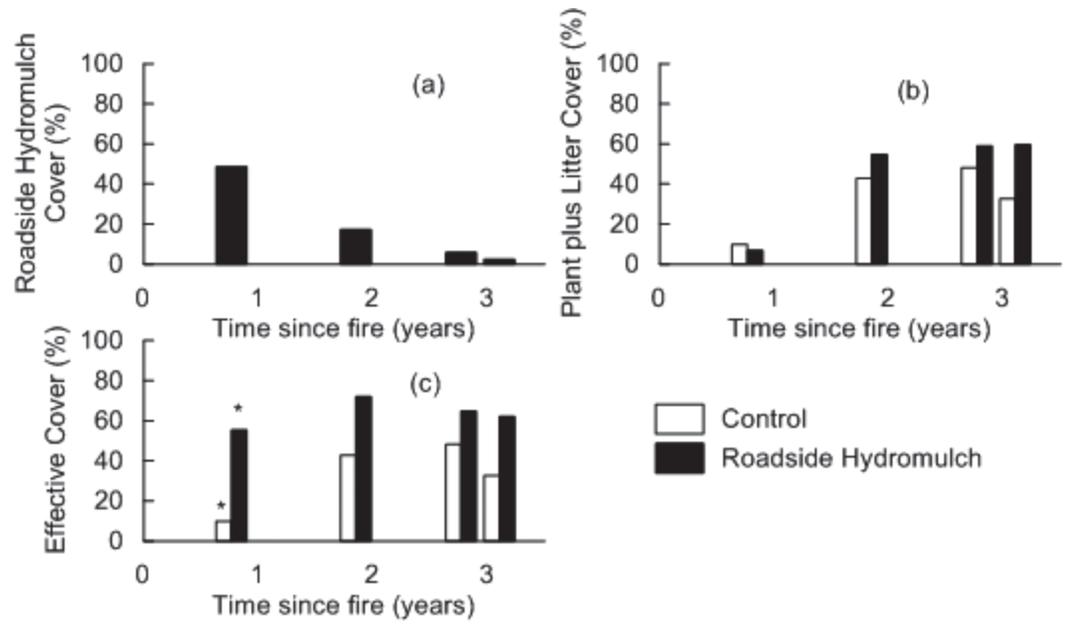
Initial roadside hydromulch cover averaged 44 percent and declined to 2 percent after 3 years (fig. 4a) Plant plus litter reached a maximum of nearly 50 percent at the end of the second growing season (fig. 4b). There was no statistically significant difference in plant plus litter between the control and roadside hydromulch. The combination of hydromulch cover and plant plus litter comprises the effective ground cover, a measure of protection from raindrop erosion. The roadside hydromulch mix contained grass seed, but while the measured effective ground cover was higher on the roadside hydromulch plots compared to the control plots, the only statistically significant difference was in the first year immediately after application of the roadside hydromulch (fig. 4c). The predominant ground cover on the control plots was forbs compared to grasses on the hydromulch plots (figs. 5 and 6).

Figure 4—Cutslope cover vs. time on Tripod Complex Fires: (a) roadside hydromulch cover, (b) plant plus litter cover, and (c) effective ground cover (roadside hydromulch plus plant plus litter). Asterisks indicate statistically significant differences between control and roadside hydromulch.

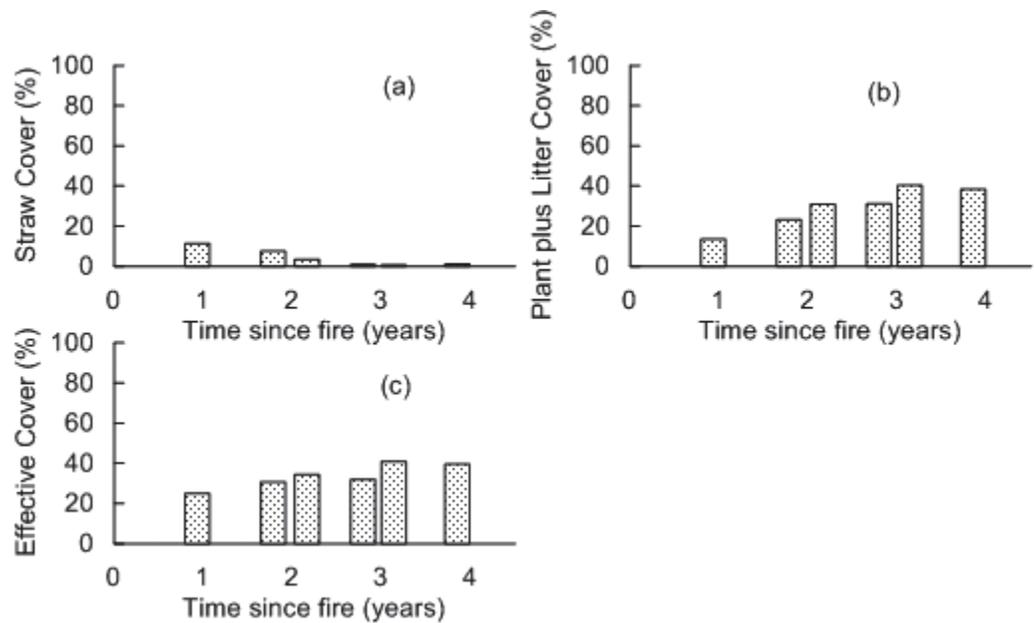
The upland pre-fire forested sections did not receive intentional aerial straw mulch application. However, two of the four FS road 3700 plots received accidental aerial straw mulch application of less than 20 percent ground cover. This unintended aerial straw mulch application changed with time from an initial cover of 10 percent to less than 1 percent at the end of the study (fig. 7a). Plant plus litter and effective ground cover peaked after the end of the second growing season at 40 percent (figs. 7b and c). This peak was about 10 percentage points less than the hydromulch cutslope plots.

Figure 7—Upland ground cover vs. time on Tripod Complex Fires: (a) incidental straw cover, (b) average plant plus litter cover, and (c) effective ground cover (straw plus plant plus litter).

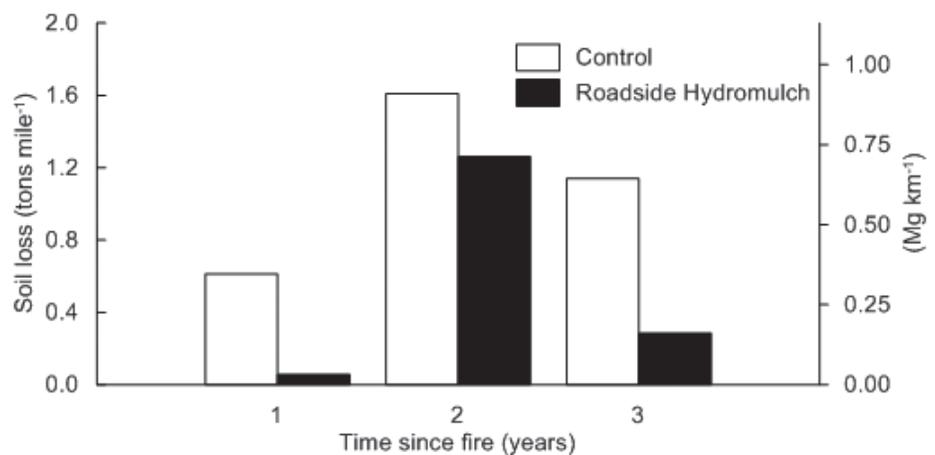
Soil loss from the cutslopes at the end of 3 years averaged 0.95 tons mi⁻¹ (0.54 kg km⁻¹) of road length on the control compared to 0.46 tons mi⁻¹ (0.26 kg km⁻¹) on the hydromulch. The mixed model did not detect a statistically significant difference in the 3-year average soil loss between the control and the roadside hydromulch (fig. 8). Additionally, the treatment by year interaction did not detect any statistically significant difference among the treatments within each of the 3 years. The 3-year mitigation due to roadside hydromulch was 52 percent.

Figure 8—Soil loss from Tripod Complex Fires road cutslopes. Only in year one was there a statistically significant difference between control and hydromulch. Asterisks indicate statistically significant differences between control and roadside hydromulch.

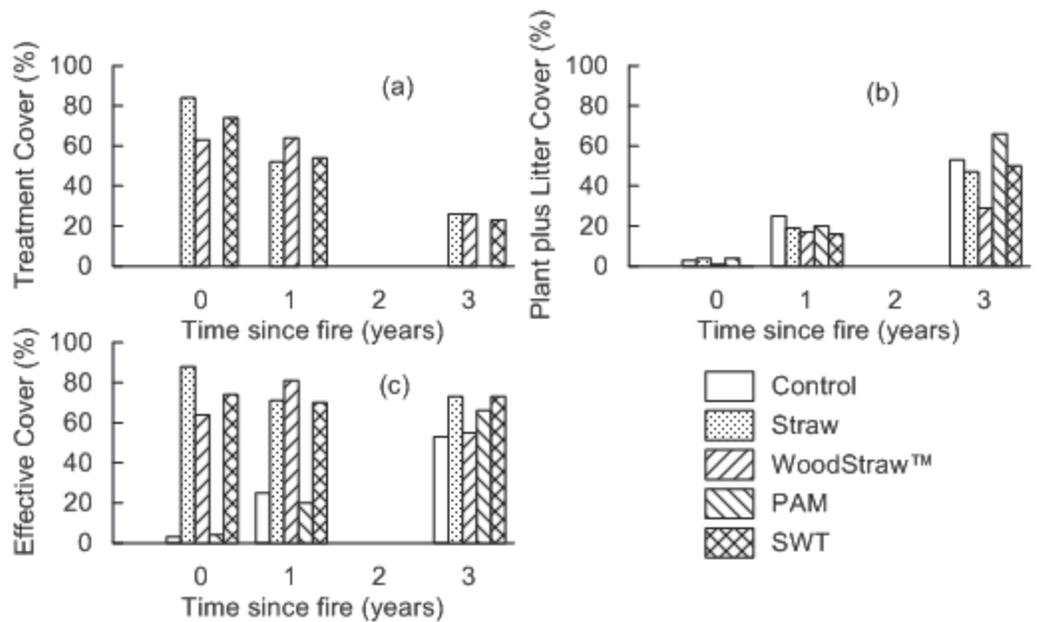
Initial cutslope mulch treatments ranged from a high of 84 percent ground cover for the straw mulch to a low of 63 percent for the Woodstraw™ (fig. 16a). After 3 years, all of the treatments had declined in a linear manner to approximately 25 percent ground cover. Vegetation cover in years three and four may have covered the mulches resulting in them being undercounted. The mixed model indicated a statistically significant difference between Woodstraw™ and straw mulch and between Woodstraw™ and SWT in year one indicating that the Woodstraw™ was applied at a lower initial cover than the straw mulch or SWT. After year one, there were no statistically significant differences in treatment cover among straw mulch, Woodstraw™, and SWT.

Plant plus litter cover—Plant plus litter cover on all the treatments (fig. 16b) reached a maximum at the end of the study ranging from a high of 66 percent on the PAM to a low of 29 percent on the Woodstraw™. The mixed model indicated a statistically significant difference in plant plus litter cover between the control and Woodstraw™ indicating that plant regrowth was slower on the sections treated with Woodstraw™. Plant regrowth on all the other treatments was not distinguishable from that on the control sections.

Effective ground cover—The combination of mulch treatment cover and plant plus litter constitutes effective ground cover. One year after the fire, the control and PAM effective ground cover averaged 23 percent compared to 74 percent for straw mulch, Woodstraw™, and SWT (fig. 16c). Three years after the fire, the range of all the treatments was 53 percent on the control to 73 percent on both the straw mulch and SWT.

Figure 16—Cutslope cover at Cascade Complex Fires. There were no statistically significant annual pairwise comparisons among the treatments in (a) or (b). In (c) at year 0, all pairwise comparisons with the control except with PAM were statistically significant; all pairwise comparisons with PAM except with the control were statistically significant; and the pairwise comparison between straw and WoodStraw™ was statistically significant. In (c) at year one, the pairwise comparison between PAM and straw and the pairwise comparison between PAM and WoodStraw™ were statistically significant differences. In (c) at year three, there were no statistically significant pairwise differences.

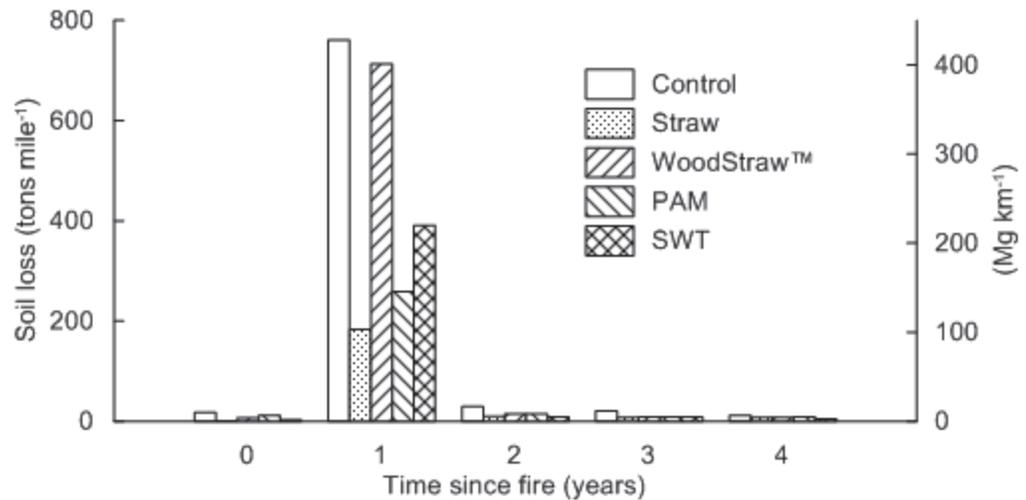
Soil loss—Soil loss from the cutslopes at the end of 4 years was highest from the control at 840 tons mi⁻¹ (470,000 kg km⁻¹) of road and lowest from the straw mulch at 210 tons mi⁻¹ (120,000 kg km⁻¹) of road (fig. 17). Between 88 and 96 percent of the cumulative sediment occurred in the first year after the fire.

The mixed model indicated that soil loss from the control was significantly higher than the straw mulch. None of the treatments (straw mulch, SWT, PAM, or Woodstraw™) resulted in soil loss values that were significantly different from one another. Thus, for the 4 years following the fire our study could conclude that only the straw mulch statistically outperformed the control. The treatment by year interaction indicated no statistically significant differences.

Figure 17—Soil loss from cutslopes, Cascade Complex Fires. There were no statistically significant annual pairwise comparisons among the treatments.
